**Flood Control Project Maintenance
Levee Inspections****LMA District Cover Sheet****Spring 2011 Levee Inspection Results****San Joaquin County Flood Control and Water Conservation District**

Spring 2011 Levee Inspection Results

San Joaquin County Flood Control and Water Conservation District

Waterway			Bank	Unit Miles
Unit No. 01 Littlejohn Creek			Left	2.87

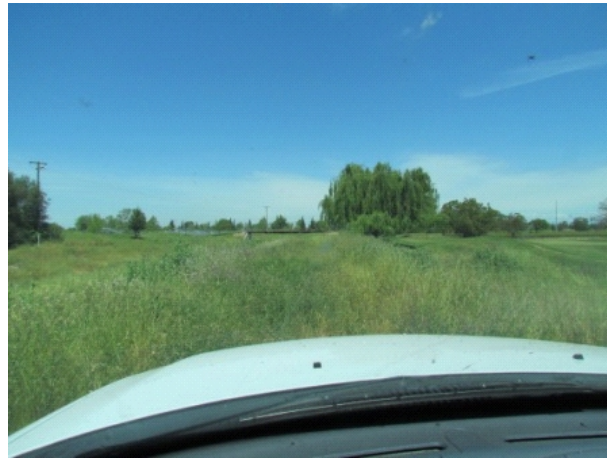
pkazi_s_20110502_517.jpg

Vegetation is covering the crown of the levee. The picture was taken from the crown looking upstream.

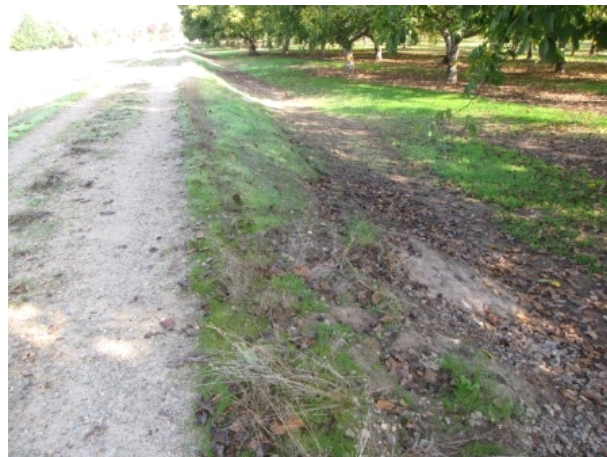
pkazi_s_20110328_087.jpg

Levee Mile Report Line	179
Start Levee Mile	15.41
End Levee Mile	15.41
Location	Land Side
Category	Earthen Levee
Item	Animal Control

View of rodent activity on the landward slope looking upstream.

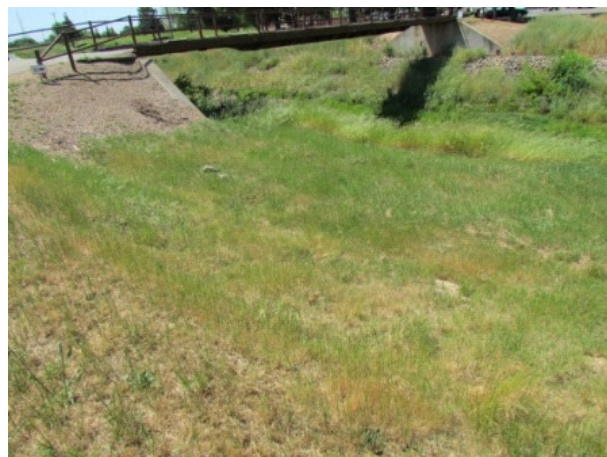
pkazi_s_20110502_518.jpg

Levee Mile Report Line	182
Start Levee Mile	15.72
End Levee Mile	15.72
Location	Water Side
Category	Earthen Levee
Item	Slope Stability

Depression and rutting caused by vehicle traffic was regraded and seeds were placed for erosion control. The picture was taken from the crown looking downstream.

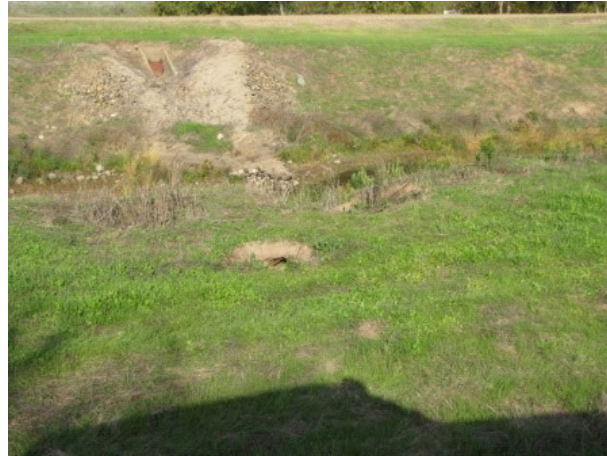
pkazi_s_20110328_089.jpg

View of erosion on the shoulder of the waterward berm looking toward the channel.

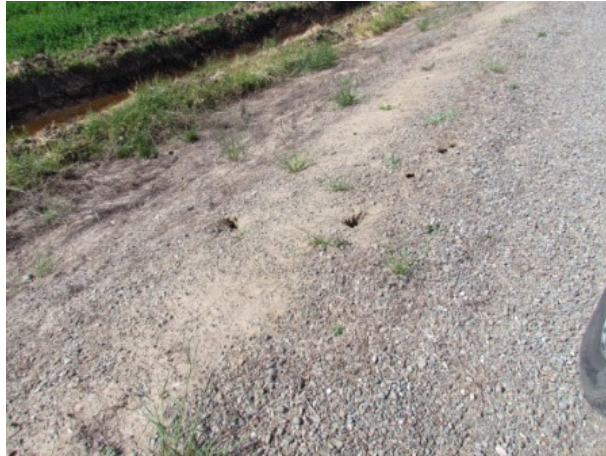
pkazi_s_20110508_530.jpg

Visible rodent holes was found on the shoulder of the landside of the levee. The picture was taken from the crown looking downstream.

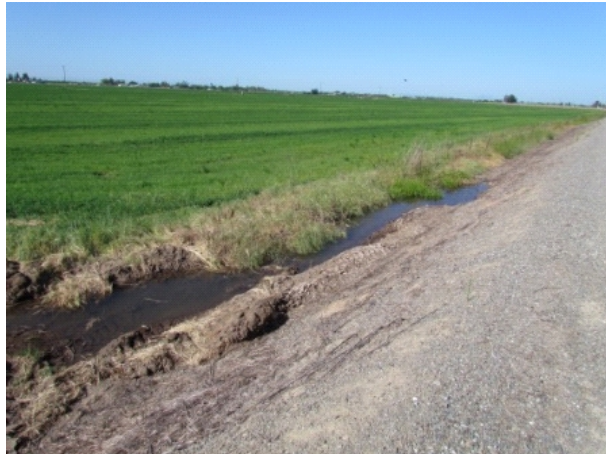
pkazi_s_20110508_529.jpg

Levee Mile Report Line	3
Start Levee Mile	0.42
End Levee Mile	0.42
Location	Land Side
Category	Earthen Levee
Item	Encroachments

Agriculture ditch with running water at the toe of the landside of the levee. The picture was taken from the crown looking downstream.

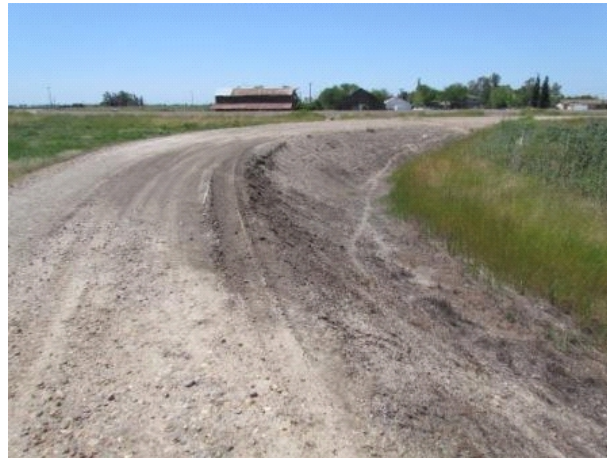
pkazi_s_20110508_538.jpg

Erosion was found on the shoulder of the landside of the levee. The picture was taken from the crown looking downstream.

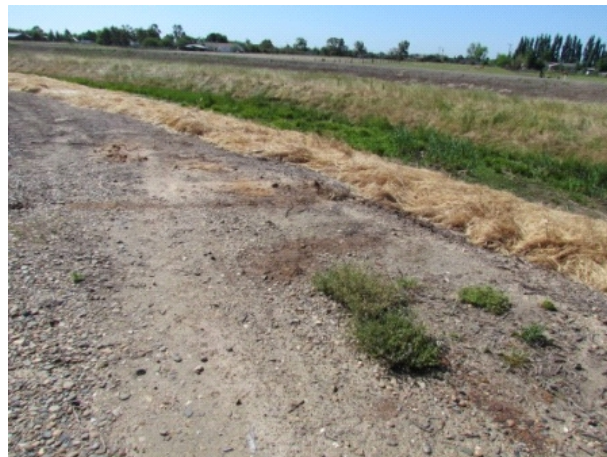
pkazi_s_20110508_536.jpg

Levee Mile Report Line	5
Start Levee Mile	0.59
End Levee Mile	0.59
Location	Land Side
Category	Earthen Levee
Item	Encroachments

Abandon pipe was removed from the waterside of the levee. The picture was taken from the crown looking downstream.

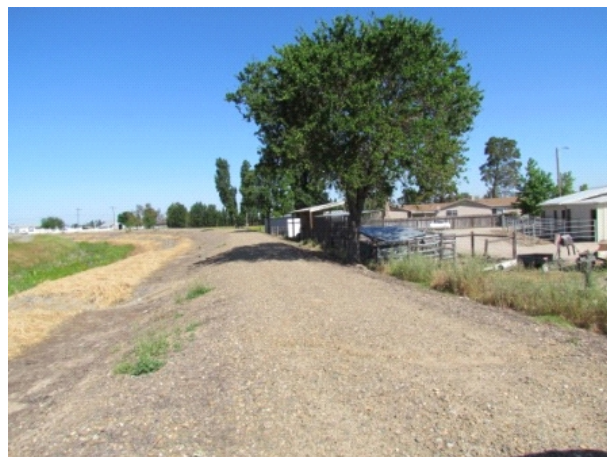
pkazi_s_20110508_537.jpg

Levee Mile Report Line	5
Start Levee Mile	0.59
End Levee Mile	0.59
Location	Land Side
Category	Earthen Levee
Item	Encroachments

Tree was trimmed to have visibility of the landside of the levee. The picture was taken from the crown looking upstream.

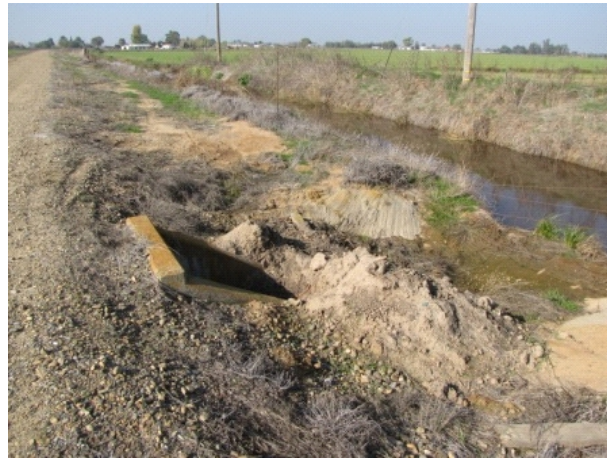
pkazi_s_20110328_149.jpg

View of the entrance to the project drainage culvert blocked by soil placed by the landowner on the landward side looking downstream.

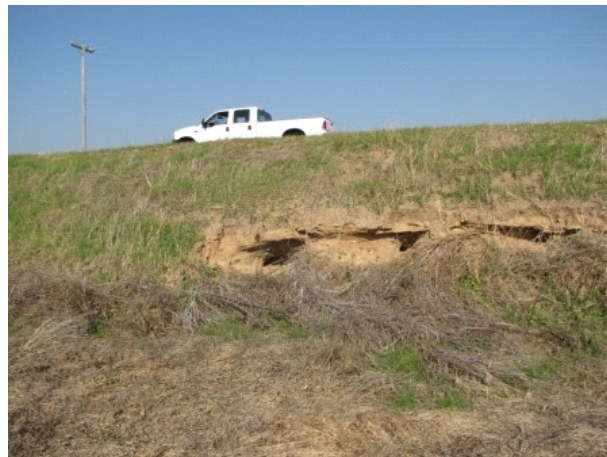
pkazi_s_20110328_148.jpg

Levee Mile Report Line	10
Start Levee Mile	0.87
End Levee Mile	0.87
Location	Water Side
Category	Earthen Levee
Item	Animal Control

View of rodent holes in the waterward berm from the channel.

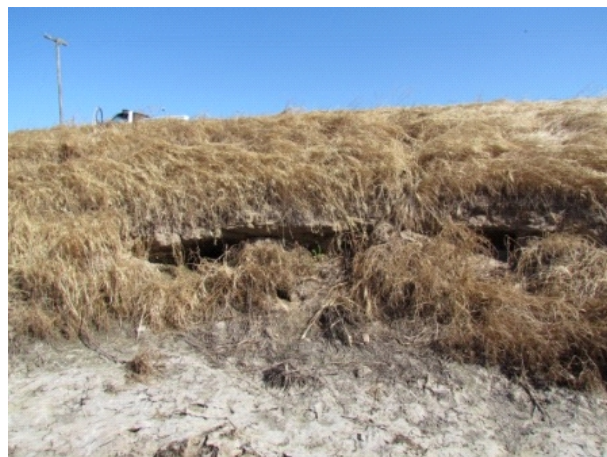
pkazi_s_20110508_535.jpg

Levee Mile Report Line	10
Start Levee Mile	0.87
End Levee Mile	0.87
Location	Water Side
Category	Earthen Levee
Item	Animal Control

Erosion above the pilot channel was located but it didn't look like rodent holes. The picture was taken from the toe at the waterside of the levee looking towards the crown.

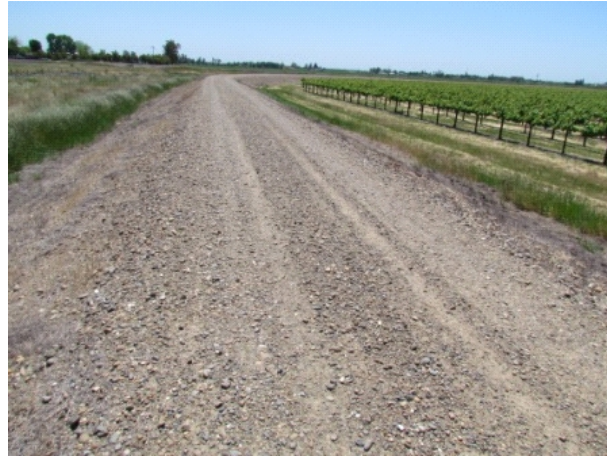
Levee Mile Report Line	2
Start Levee Mile	0.12
End Levee Mile	0.12
Location	Crown
Category	Earthen Levee
Item	Crown Surface / Depressions / Rutting
Depression on the crown was repaired. The picture was taken from the crown looking upstream.	
pkazi_s_20110508_544.jpg

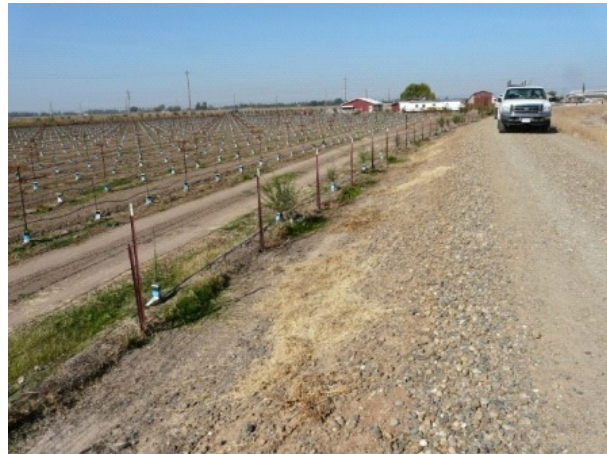
Levee Mile Report Line	4
Start Levee Mile	0.17
End Levee Mile	0.49
Location	Land Side
Category	Earthen Levee
Item	Encroachments
Fence located from LM 0.17 to LM 0.49 and crops located from LM 0.17 to LM 0.41 within 10' from landside toe of levee.	
pkazi_s_20110328_152.JPG

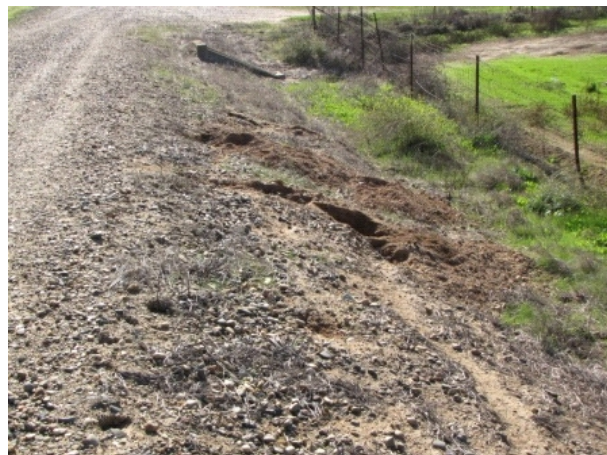
Levee Mile Report Line	5
Start Levee Mile	0.17
End Levee Mile	0.17
Location	Land Side
Category	Earthen Levee
Item	Animal Control
View of rodent holes in the landward slope looking downstream.	
pkazi_s_20110328_160.jpg

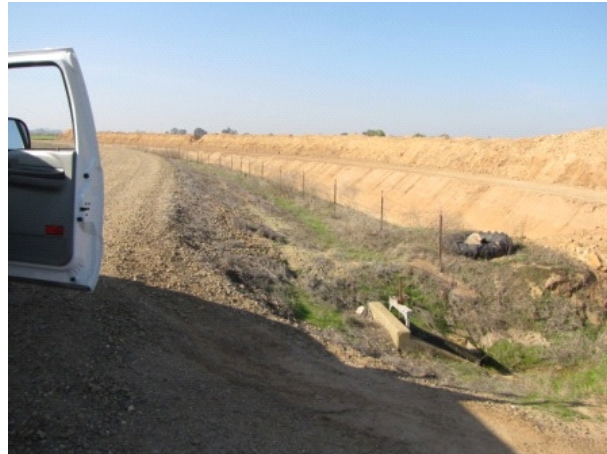
pkazi_s_20110328_155.jpg

View of a large ditch adjacent to the landward toe of the levee looking along the landward toe, downstream at the upstream limit of the ditch.

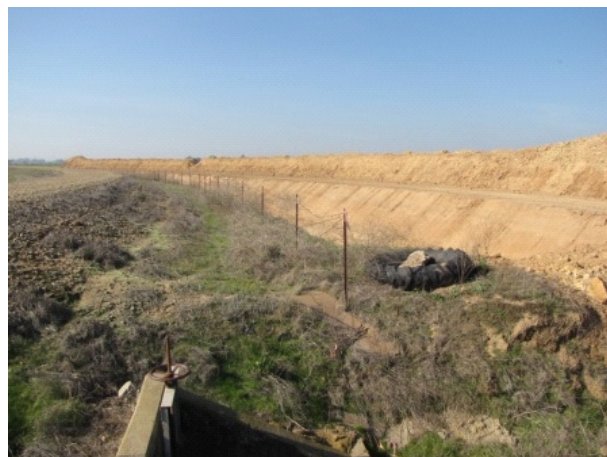
pkazi_s_20110328_156.jpg

Levee Mile Report Line	13
Start Levee Mile	1.07
End Levee Mile	1.16
Location	Land Side
Category	Earthen Levee
Item	Slope Stability

Additional view of the ditch looking along the landward toe, downstream at the upstream limit of the ditch.

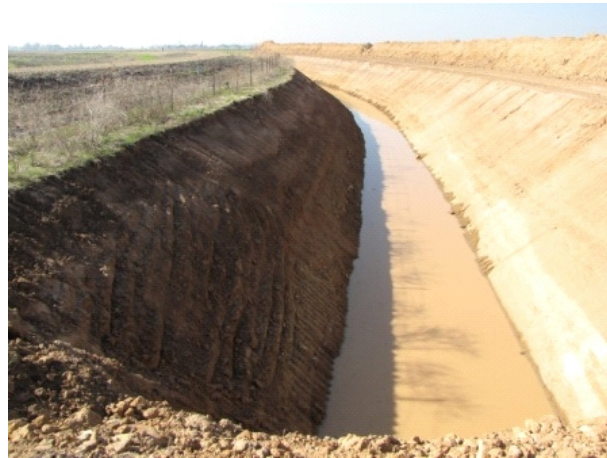
pkazi_s_20110328_157.jpg

View of the ditch adjacent to the landward toe looking upstream at the upstream limit of the ditch.

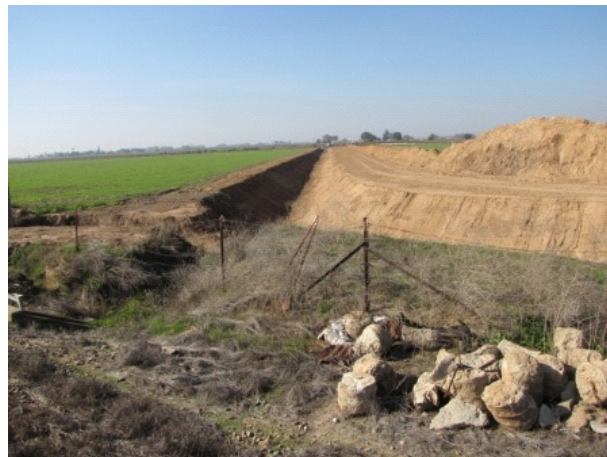
pkazi_s_20110328_158.jpg

View of the ditch adjacent to the landward toe of the levee looking landward at the downstream limit of the ditch.

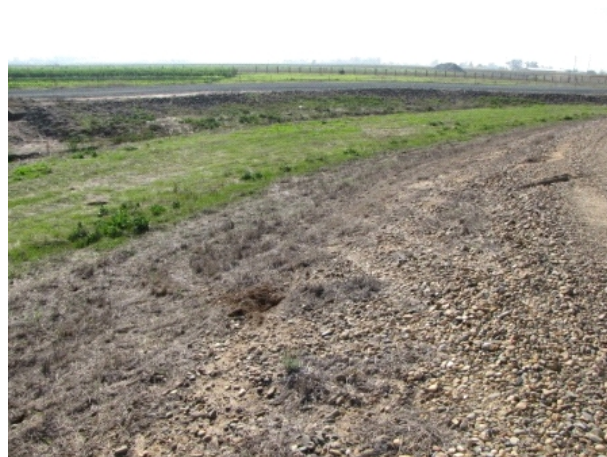
pkazi_s_20110328_154.jpg

Levee Mile Report Line	15
Start Levee Mile	1.58
End Levee Mile	1.58
Location	Water Side
Category	Earthen Levee
Item	Animal Control

View of a rodent hole in the waterward slope looking downstream.

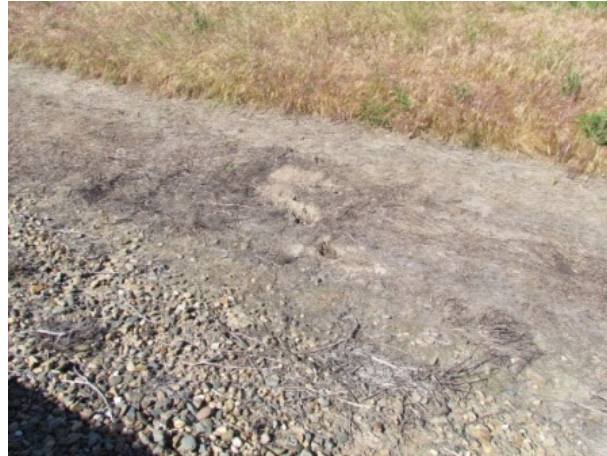
pkazi_s_20110508_532.jpg

Rodent holes were located on the waterside of the levee. The picture was taken from crown looking downstream.

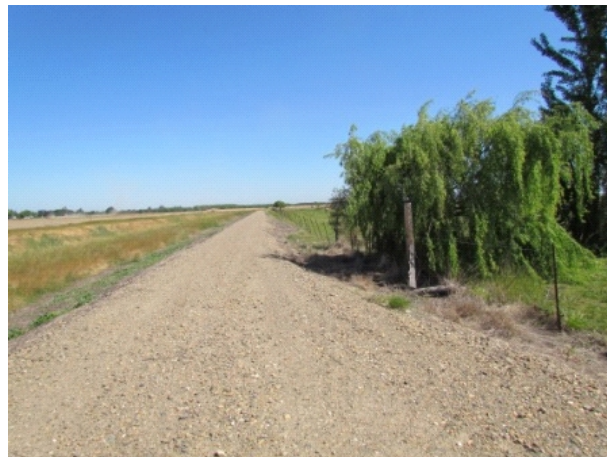
pkazi_s_20110508_534.jpg

Levee Mile Report Line	3
Start Levee Mile	0.78
End Levee Mile	1.30
Location	Land Side
Category	Earthen Levee
Item	Encroachments

Fences were found on the landside of the levee. Picture was taken from the crown looking upstream.

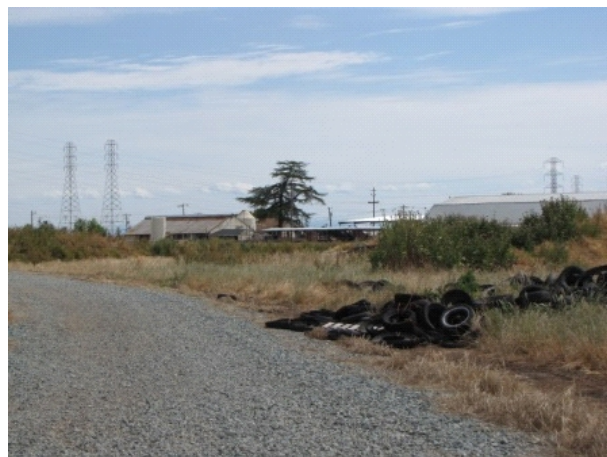
pkazi_s_20110328_167.jpg

Levee Mile Report Line	6
Start Levee Mile	1.85
End Levee Mile	1.85
Location	Land Side
Category	Earthen Levee
Item	Encroachments

View of tires on the landward portion of the levee looking upstream.

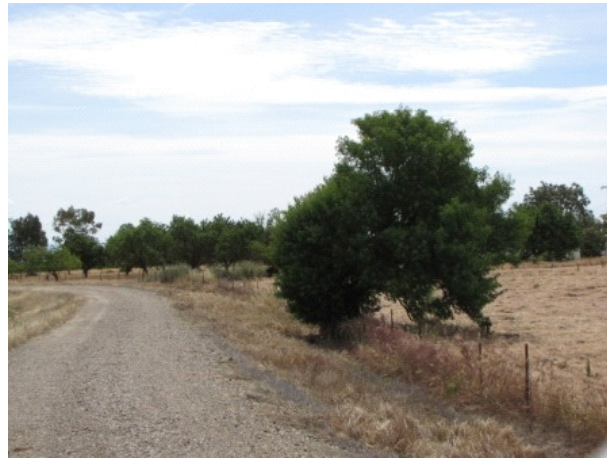
pkazi_s_20110328_168.jpg

View of a tree blocking visibility at the landward toe looking upstream.

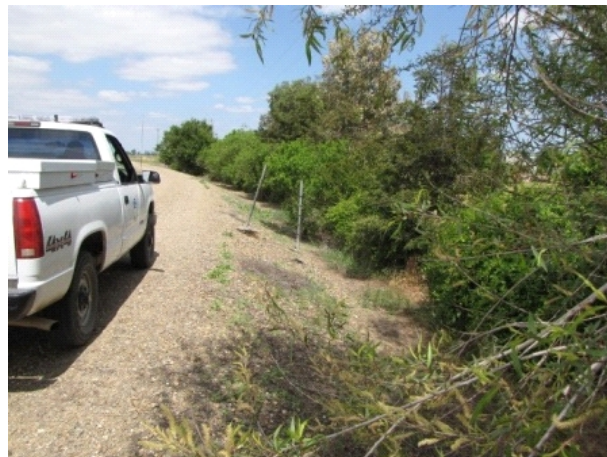
pkazi_s_20110328_163.jpg

Levee Mile Report Line	9
Start Levee Mile	2.37
End Levee Mile	2.43
Location	Land Side
Category	Earthen Levee
Item	Encroachments

Landscaping on landward levee slope and within 10' of the toe.

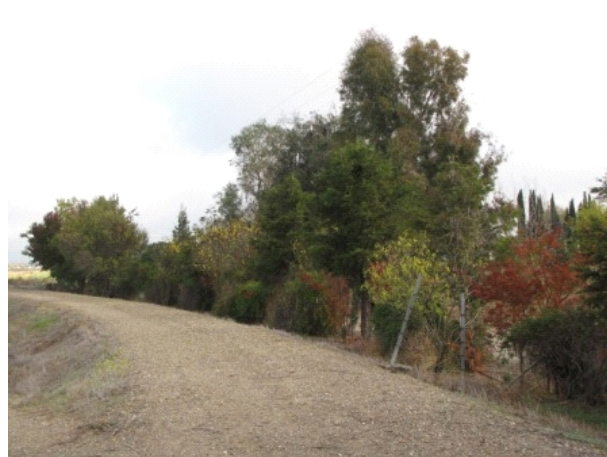
pkazi_s_20110328_164.jpg

Levee Mile Report Line	9
Start Levee Mile	2.37
End Levee Mile	2.43
Location	Land Side
Category	Earthen Levee
Item	Encroachments

Updated view of landscaping as of fall 2009. The county has removed as much of the vegetation on the creek side of the fence as they can at this time.

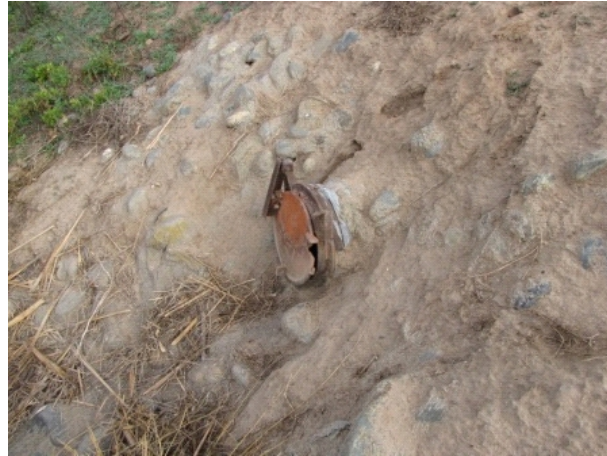
pkazi_s_20110328_166.jpg

View of a flap gate that has been damaged and is unable to completely close.

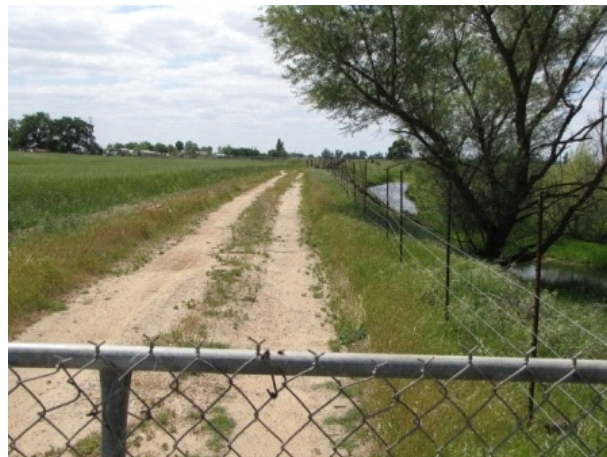
pkazi_s_20110328_165.jpg

Levee Mile Report Line	11
Start Levee Mile	3.53
End Levee Mile	3.92
Location	Crown
Category	Earthen Levee
Item	Encroachments

Fence along waterward sholder and crown of access road. The road cannot be driven through as the fence blocks access. The gate does not have a county key on the gate.

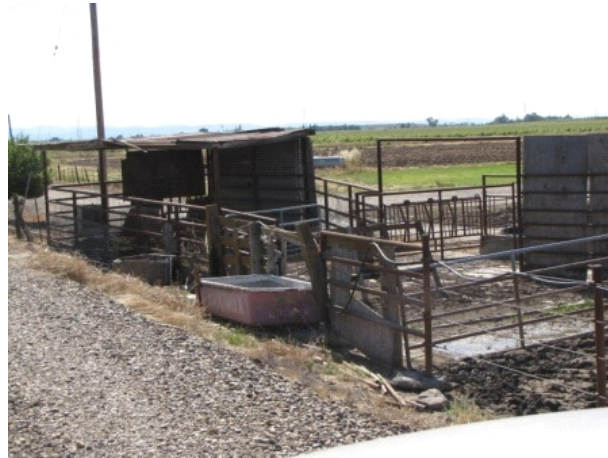
pkazi_s_20110328_169.jpg

View of a tub/tank on the landward slope blocking access and visibility looking upstream.

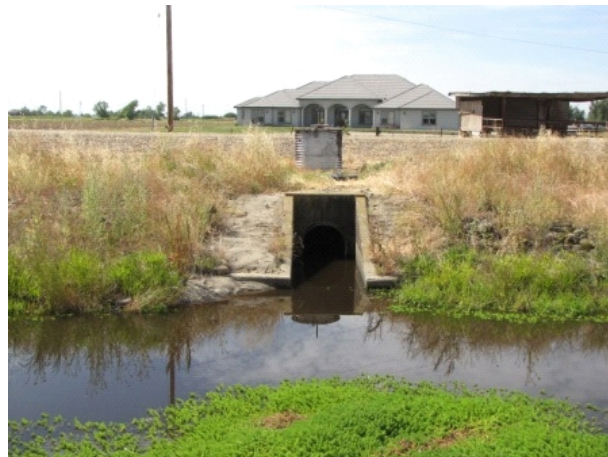
pkazi_s_20110328_171.jpg

Levee Mile Report Line	3
Start Levee Mile	0.40
End Levee Mile	0.40
Location	Water Side
Category	Interior Drainage & Piping Systems
Item	Flap Gates

View of a outfall pipe with a missing flap gate looking from across the channel.

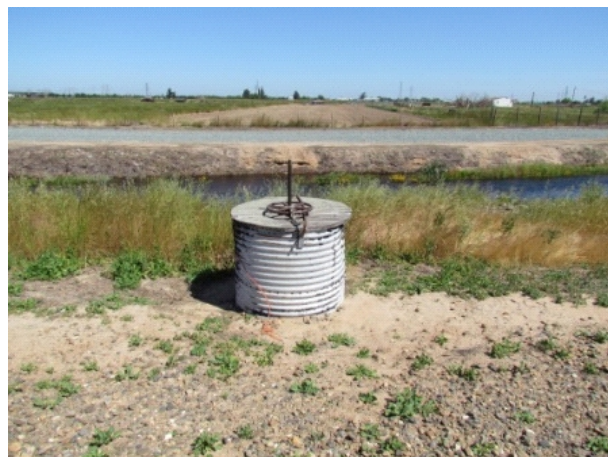
pkazi_s_20110509_545.jpg

Levee Mile Report Line	3
Start Levee Mile	0.40
End Levee Mile	0.40
Location	Water Side
Category	Interior Drainage & Piping Systems
Item	Flap Gates

This location has a screw gate and NOT flap gate. The gate remains open during April through November for agricultural purpose and this gate is maintained by the LMA. The picture was taken from crown of the levee looking upstream.

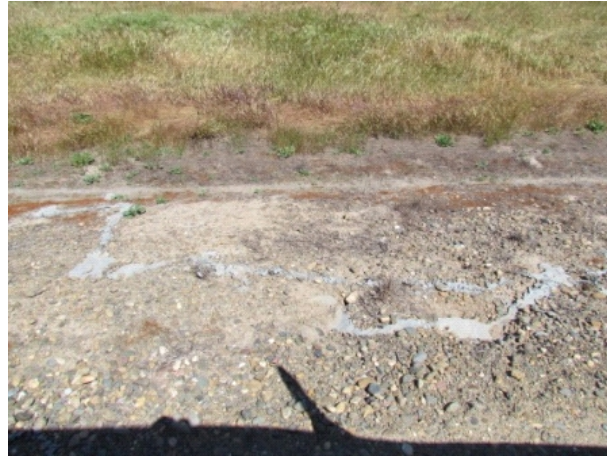
pkazi_s_20110508_539.jpg

Rodent holes were grouted by the LMA at the waterside of the levee. The picture was taken from the crown looking towards the toe.

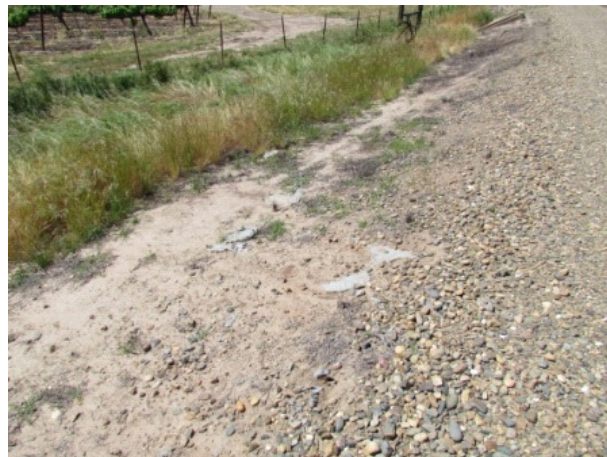
pkazi_s_20110508_540.jpg

Levee Mile Report Line	9
Start Levee Mile	1.11
End Levee Mile	1.11
Location	Land Side
Category	Earthen Levee
Item	Animal Control

Rodent holes were grouted by the LMA on the landside of the levee. The picture was taken from the crown looking upstream.

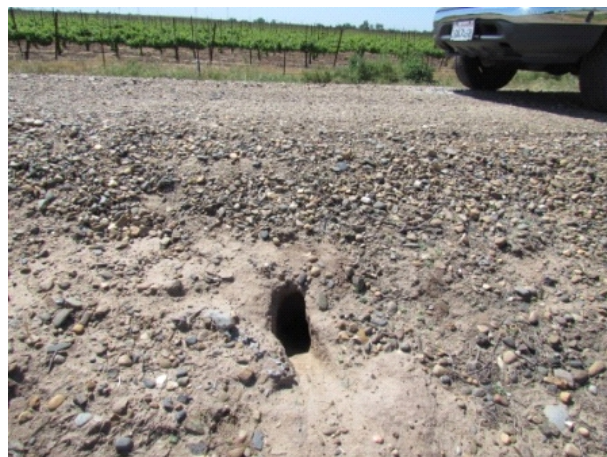
pkazi_s_20110508_541.jpg

Levee Mile Report Line	11
Start Levee Mile	1.15
End Levee Mile	1.15
Location	Water Side
Category	Earthen Levee
Item	Animal Control

Rodent hole was found on the shoulder of waterside of the levee. The picture was taken from the waterside of the levee looking towards the landside.

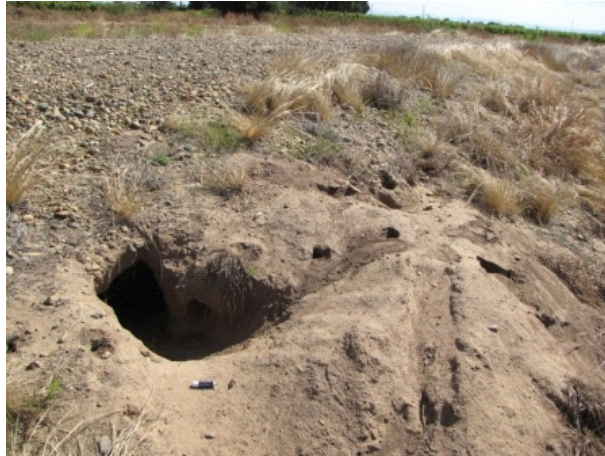
pkazi_s_20110328_170.jpg

View of a large hole in the landward slope of the levee looking upstream.

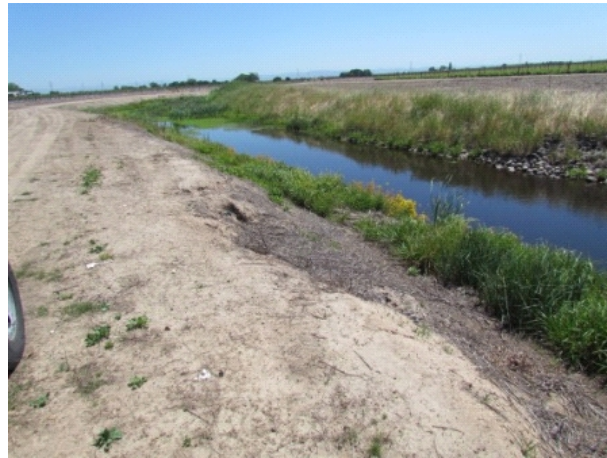
pkazi_s_20110508_543.jpg

Erosion was found on the waterside of the levee.

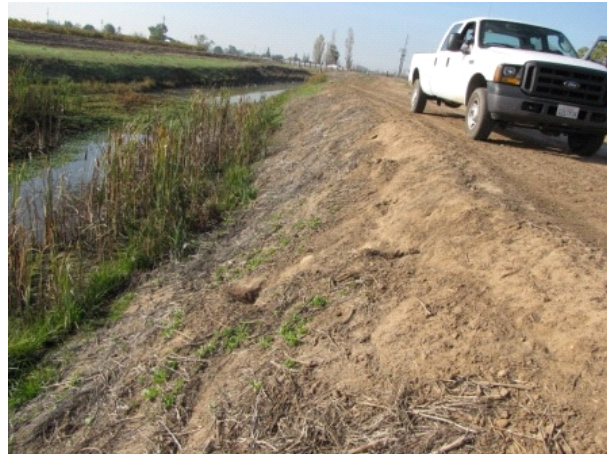
pkazi_s_20110328_173.jpg

Levee Mile Report Line	2
Start Levee Mile	0.65
End Levee Mile	0.65
Location	Water Side
Category	Earthen Levee
Item	Animal Control

View of rodent holes in the waterward berm looking downstream.

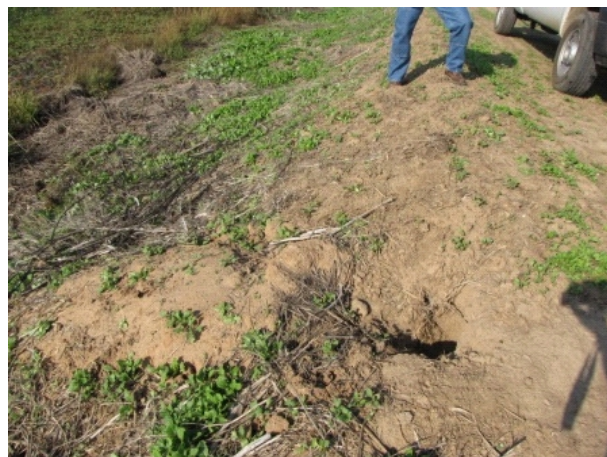
pkazi_s_20110328_174.jpg

Levee Mile Report Line	3
Start Levee Mile	0.83
End Levee Mile	0.83
Location	Water Side
Category	Earthen Levee
Item	Animal Control

View of a large diameter rodent hole in the waterward berm looking downstream.

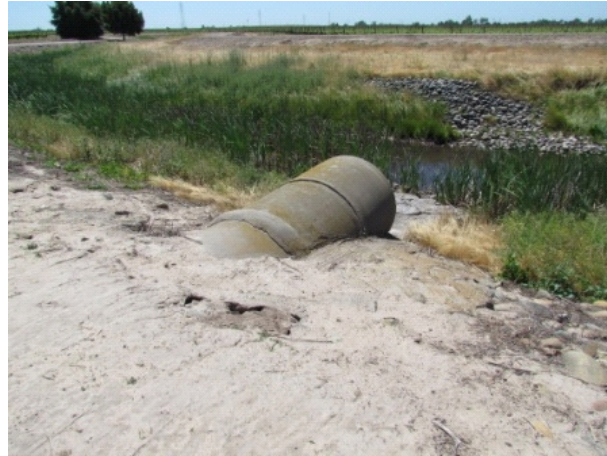
pkazi_s_20110508_542.jpg

Erosion existed on top of the pipe was repaired.
The picture was taken from the crown looking upstream.

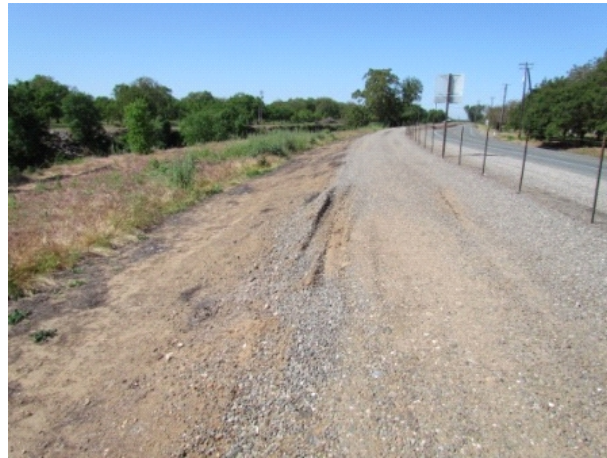
pkazi_s_20110519_554.jpg

Rutting and depression was found on the shoulder of landside of the levee. The picture was taken from the crown looking downstream.

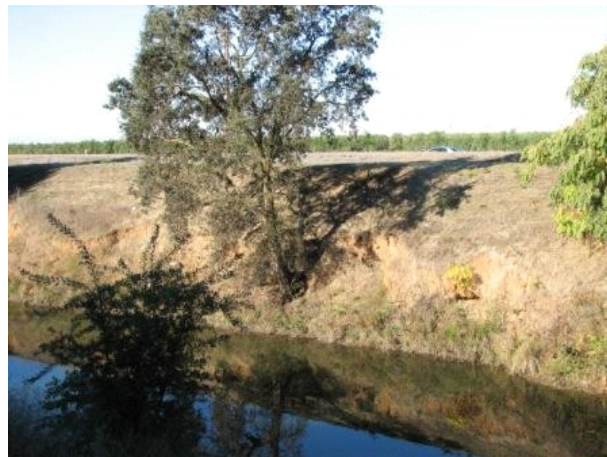
pkazi_s_20110328_189.jpg

Levee Mile Report Line	4
Start Levee Mile	0.41
End Levee Mile	1.32
Location	Water Side
Category	Supplemental
Item	DWR Erosion Survey

Looking downstream from the left bank.

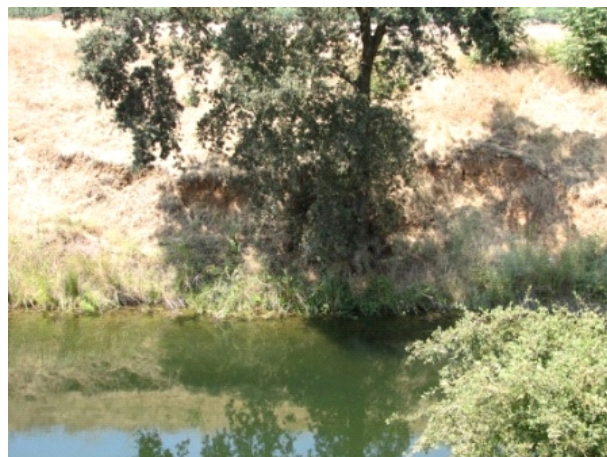
pkazi_s_20110328_190.jpg

Levee Mile Report Line	4
Start Levee Mile	0.41
End Levee Mile	1.32
Location	Water Side
Category	Supplemental
Item	DWR Erosion Survey

Picture taken in 08/12/2009. Standing from the left bank and looking directly across at a section where tree stability may be affected by erosion.

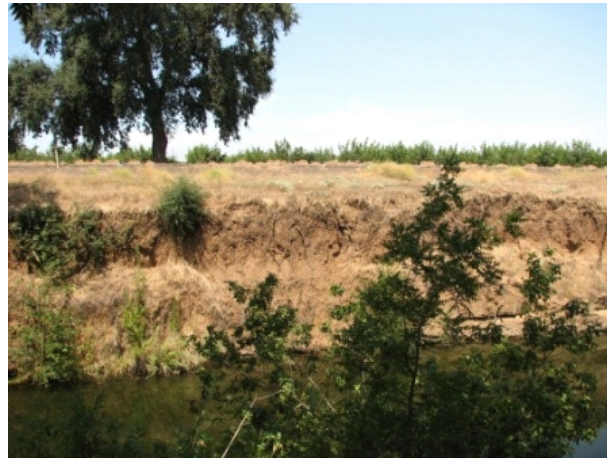
pkazi_s_20110328_191.jpg

Looking upstream from the left bank. In some section of the 4800-ft long bank erosion, there is considerable amount of berm remaining.

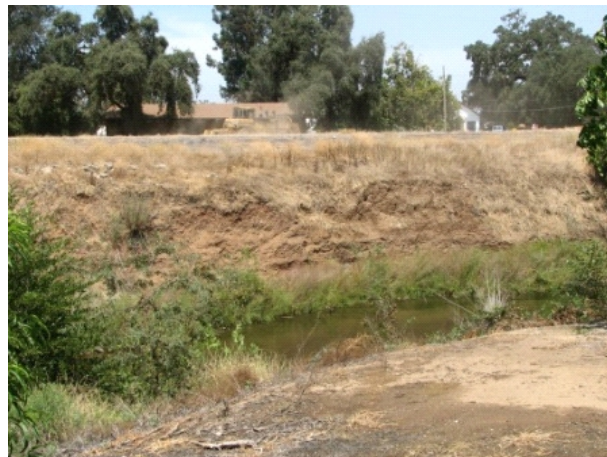
pkazi_s_20110328_192.jpg

Levee Mile Report Line	4
Start Levee Mile	0.41
End Levee Mile	1.32
Location	Water Side
Category	Supplemental
Item	DWR Erosion Survey

Standing on the left bank and looking upstream.

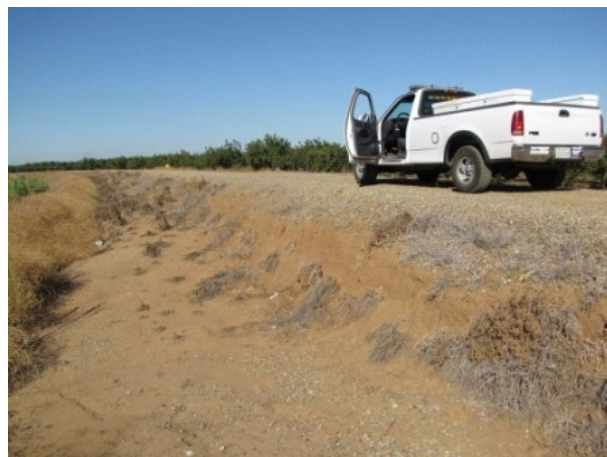
pkazi_s_20110328_256.jpg

Levee Mile Report Line	5
Start Levee Mile	1.52
End Levee Mile	1.52
Location	Water Side
Category	Earthen Levee
Item	Erosion / Bank Caving

View of erosion of waterward levee slope looking upstream.

5	1.52	1.52	Earthen Levee	Erosion / Bank Caving	WS	M	Schedule repair of erosion site prior to the next inspection. Inspector Comments: The LMA were working on fixing the erosion site using excavator during inspection.	38.040202 ° -121.032659 °	38.040202 ° -121.032659 °	995 Y	
6	1.55	1.62	Supplemental	DWR Erosion Survey	WS	U	Inspector Comments: 11/02/2010: No significant changes observed on site. Bank erosion extends approximately 100 feet downstream and 250 feet upstream of the drop structure. [2010 SiteID: NA0017U15RM1.58]	38.040170 ° -121.033800 °	38.040170 ° -121.033800 °	1 Y	
7	2.03	2.03	Earthen Levee	Slope Stability	WS	M	Repair slope instability.	38.037000 ° -121.040547 °	38.037000 ° -121.040547 °	26 Y	
8	2.08	2.08	Earthen Levee	Encroachments	WS	C	Pipe	38.036359 ° -121.041057 °	38.036359 ° -121.041057 °	2	
9	2.34	2.41	Earthen Levee	Vegetation	LS	C	Remove the wild growth other than native grasses from the levee slopes.	38.033604 ° -121.044243 °	38.033002 ° -121.045090 °	17

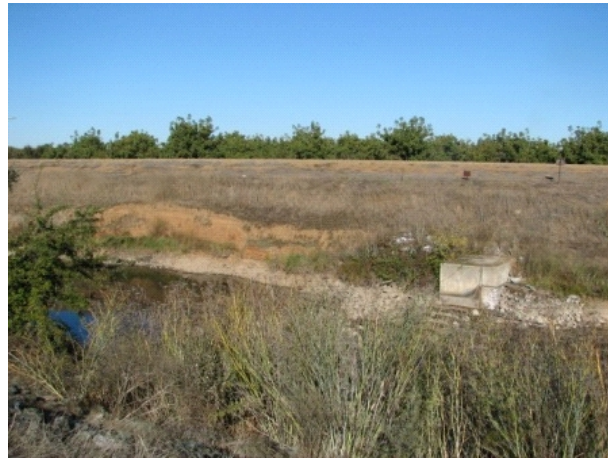
pkazi_s_20110328_176.jpg

Looking at bank erosion downstream of the drop structure.

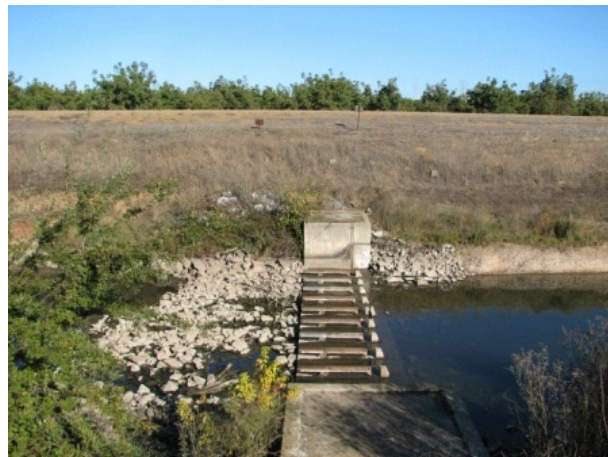
pkazi_s_20110328_177.jpg

Levee Mile Report Line	6
Start Levee Mile	1.55
End Levee Mile	1.62
Location	Water Side
Category	Supplemental
Item	DWR Erosion Survey

Looking directly at the drop structure.

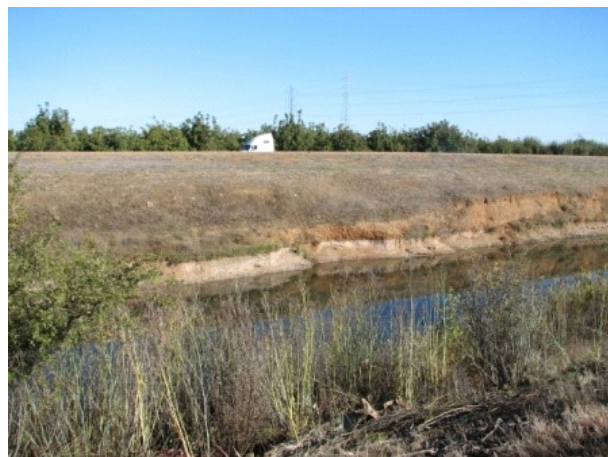
pkazi_s_20110328_178.jpg

Levee Mile Report Line	6
Start Levee Mile	1.55
End Levee Mile	1.62
Location	Water Side
Category	Supplemental
Item	DWR Erosion Survey

Looking at bank erosion upstream of the drop structure.

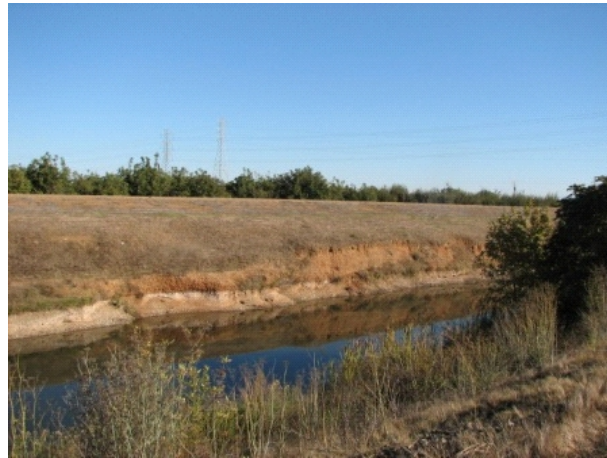
pkazi_s_20110328_179.jpg

Looking at bank erosion upstream of the drop structure.

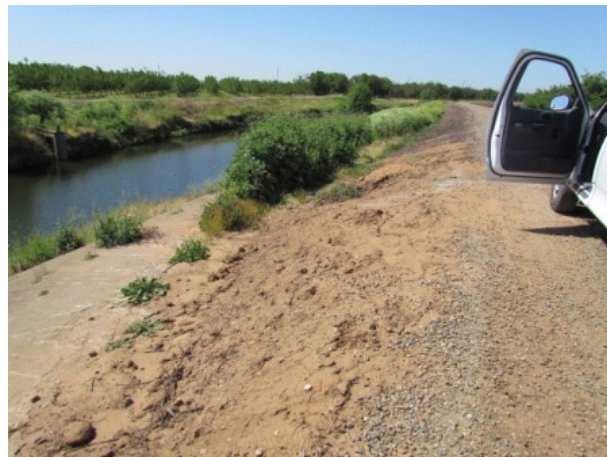
pkazi_s_20110519_555.jpg

Levee Mile Report Line	7
Start Levee Mile	2.03
End Levee Mile	2.03
Location	Water Side
Category	Earthen Levee
Item	Slope Stability

Slope stability was discovered on the waterside of the levee. The picture was taken from the crown looking downstream.

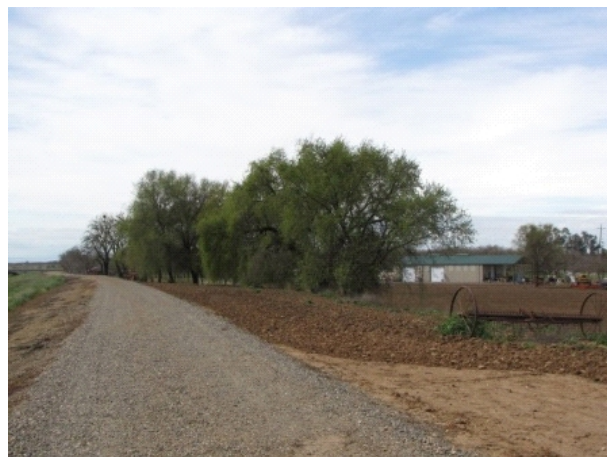
pkazi_s_20110328_199.jpg

Levee Mile Report Line	10
Start Levee Mile	2.42
End Levee Mile	2.57
Location	Land Side
Category	Earthen Levee
Item	Erosion / Bank Caving

View of the landward shoulder where a landowner has disced the levee looking downstream.

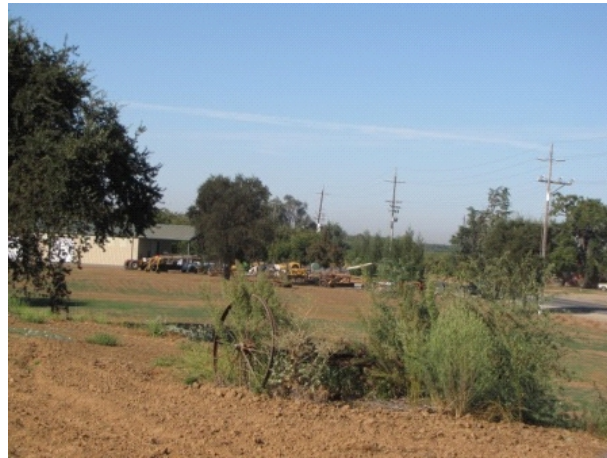
pkazi_s_20110328_198.jpg

View of equipment on the landward slope of the levee looking downstream.

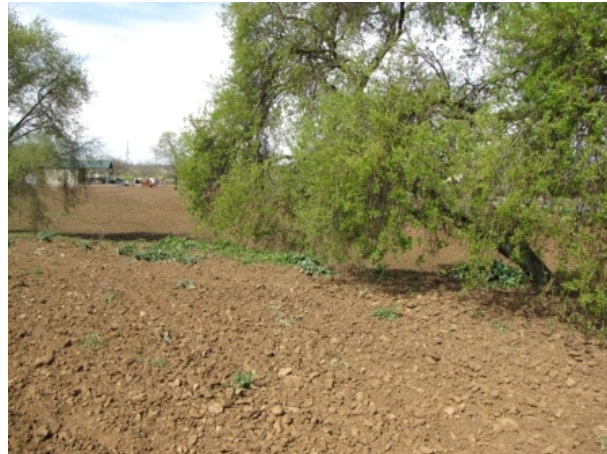
pkazi_s_20110328_201.jpg

Levee Mile Report Line	12
Start Levee Mile	2.48
End Levee Mile	2.48
Location	Land Side
Category	Earthen Levee
Item	Trim / Thin Trees

View of a tree blocking visibility on the landward slope looking downstream.

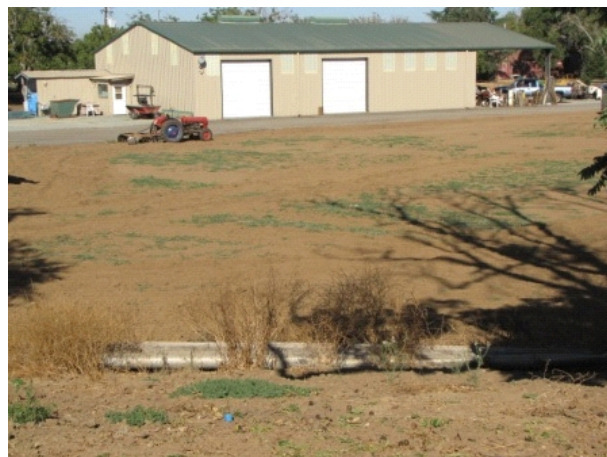
pkazi_s_20110328_205.jpg

Levee Mile Report Line	13
Start Levee Mile	2.54
End Levee Mile	2.54
Location	Land Side
Category	Earthen Levee
Item	Encroachments

View of debris at the landward toe looking landward.

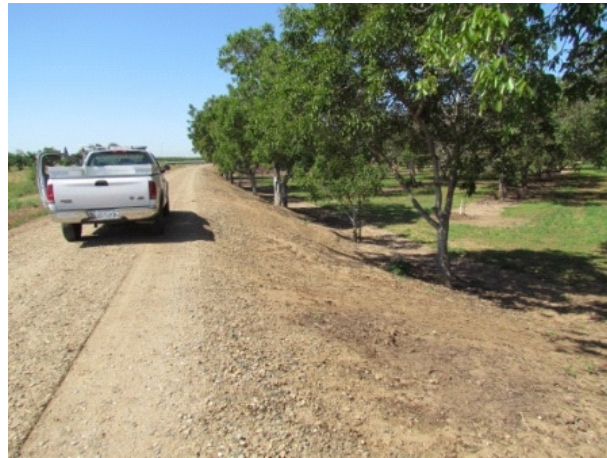
pkazi_s_20110519_556.jpg

The slope stability found on previous inspection has been repaired by the LMA. The picture was taken from the crown looking donstream.

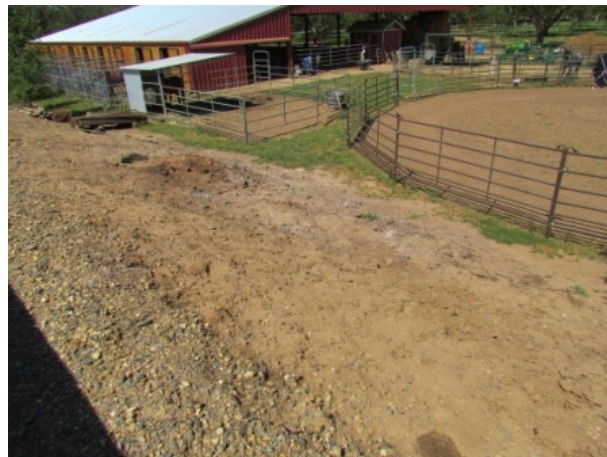
pkazi_s_20110519_557.jpg

Levee Mile Report Line	16
Start Levee Mile	2.68
End Levee Mile	2.68
Location	Land Side
Category	Earthen Levee
Item	Slope Stability

Slope stability was found on the landside of the levee. The picture was taken from the crown looking downstream.

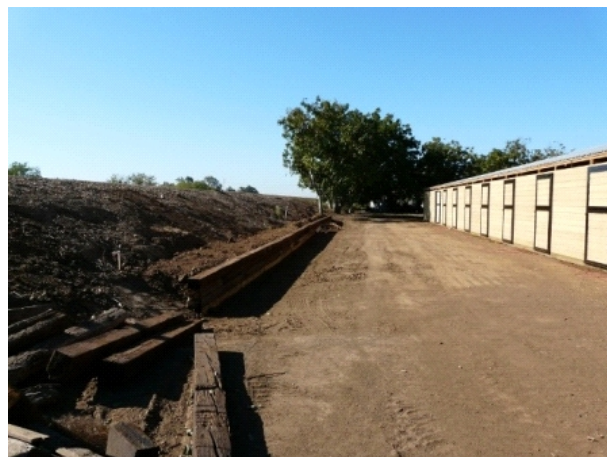
pkazi_s_20110328_217.JPG

Levee Mile Report Line	17
Start Levee Mile	2.68
End Levee Mile	2.71
Location	Land Side
Category	Earthen Levee
Item	Encroachments

Recently built retaining wall at toe of landside levee at LM 2.68.

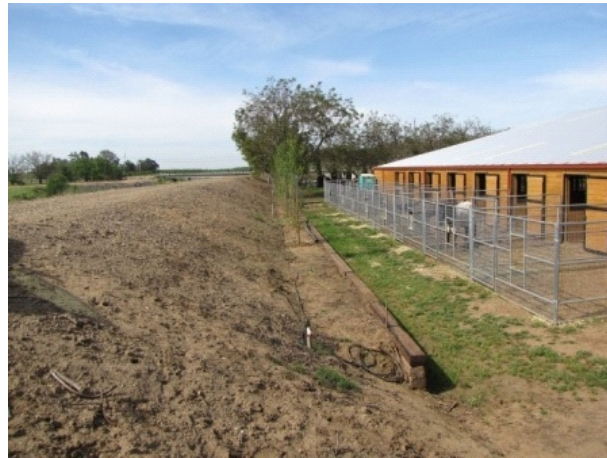
pkazi_s_20110328_218.jpg

Updated view as of Spring 2009. Landscaping and irrigation has been added at the toe of the levee.

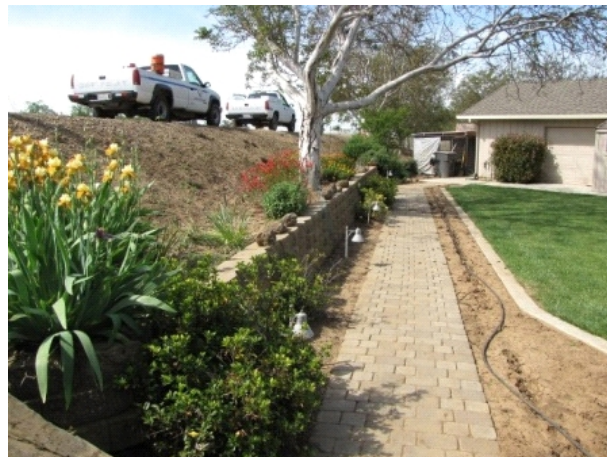
View of retaining wall and landscaping along the landward toe of the levee.

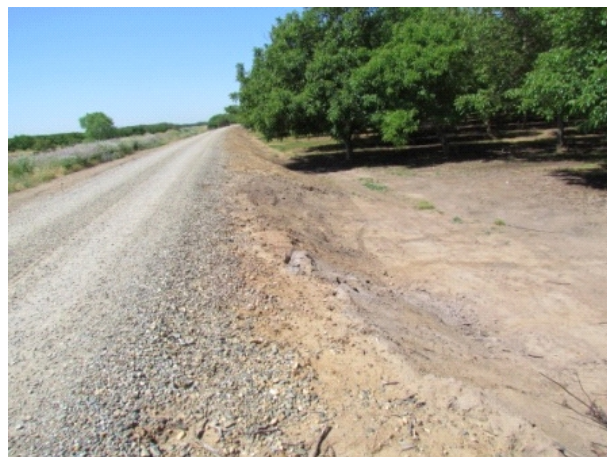
Levee Mile Report Line	21
Start Levee Mile	2.86
End Levee Mile	2.86
Location	Land Side
Category	Earthen Levee
Item	Slope Stability

Slope stability was found on the landside of the levee. The picture was taken from the crown looking downstream.

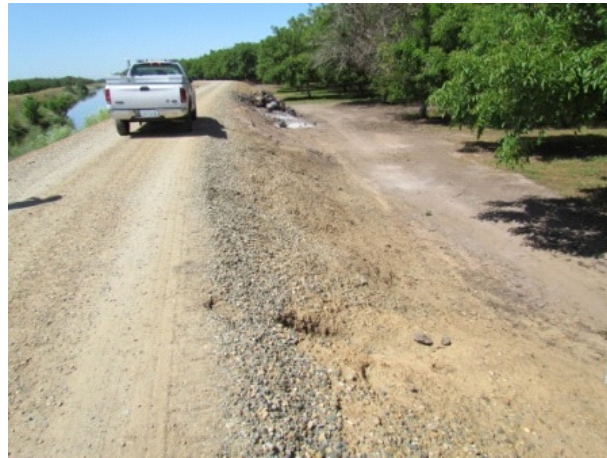
Slope stability was found on the landside of the levee. The picture was taken from the crown looking downstream.

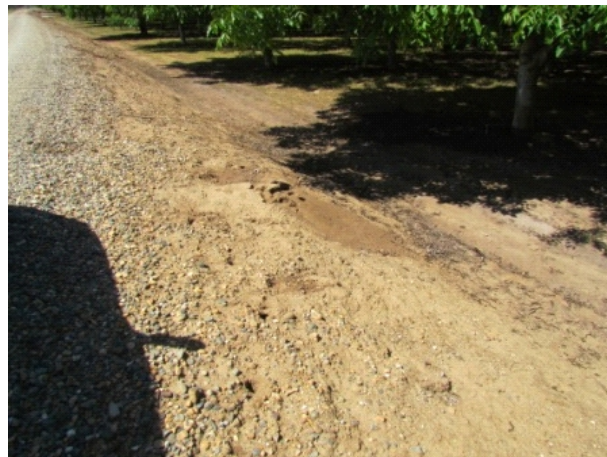
Levee Mile Report Line	27
Start Levee Mile	3.05
End Levee Mile	3.05
Location	Land Side
Category	Earthen Levee
Item	Animal Control

Animal burrow was found on the landside of the levee. The picture was taken from the crown looking downstream.

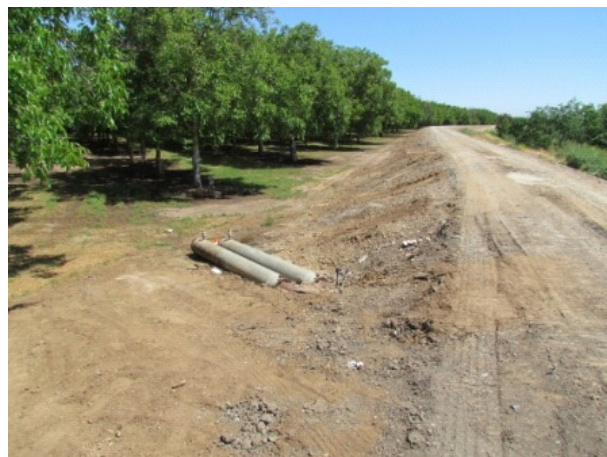
Levee Mile Report Line	28
Start Levee Mile	3.10
End Levee Mile	3.14
Location	Land Side
Category	Earthen Levee
Item	Slope Stability

Slope stability was found on the landside of the levee. The picture was taken from the crown looking upstream.

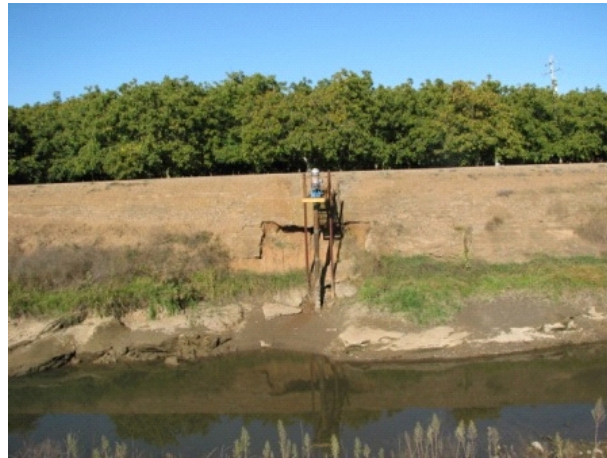
Standing on the left bank looking directly at the erosion site.

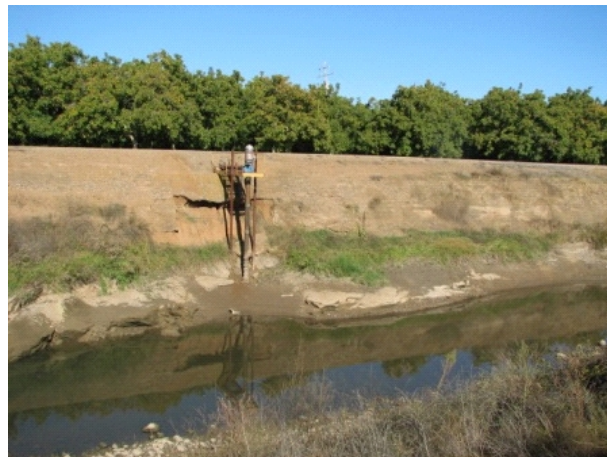
Levee Mile Report Line	30
Start Levee Mile	3.14
End Levee Mile	3.15
Location	Water Side
Category	Supplemental
Item	DWR Erosion Survey

Looking upstram of the erosion site.

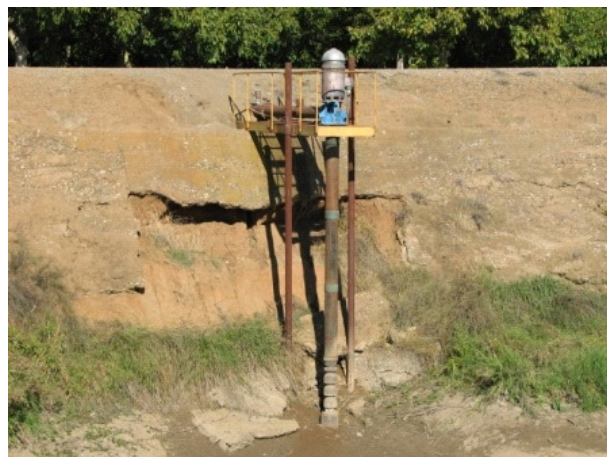
Levee Mile Report Line	30
Start Levee Mile	3.14
End Levee Mile	3.15
Location	Water Side
Category	Supplemental
Item	DWR Erosion Survey

Looking upstream of the erosion site.

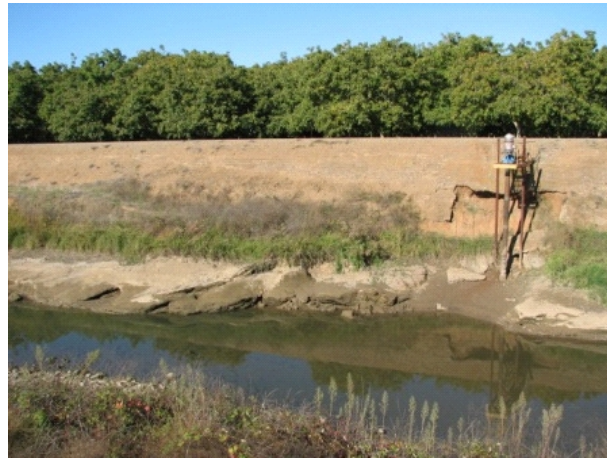
Looking downstream of the erosion site.

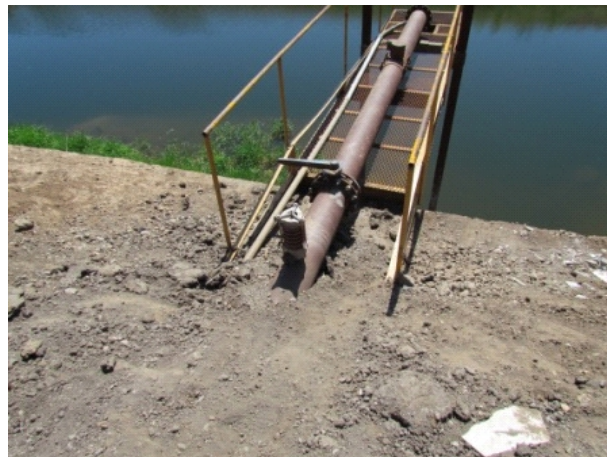
Levee Mile Report Line	31
Start Levee Mile	3.14
End Levee Mile	3.14
Location	Water Side
Category	Earthen Levee
Item	Erosion / Bank Caving

Erosion around and under the pipe has been fixed. The picture was taken from the crown looking toward the waterside.
